- UPPER LAKE MINNIE HA-HA DAM,
- LOWER LAKE MINNIE HA-HA DAM,
- LAKE MINNIE HA-HA DEVELOPMENT,
- STE. GENEVIEVE COUNTY, MISSOURI .

PHASE 1 INSPECTION REPORT. NATIONAL DAM SAFETY PROGRAM.

DECEMBER 1979

UPPER LAKE MINNIE HA-HA DAM - ID. NO. 30643

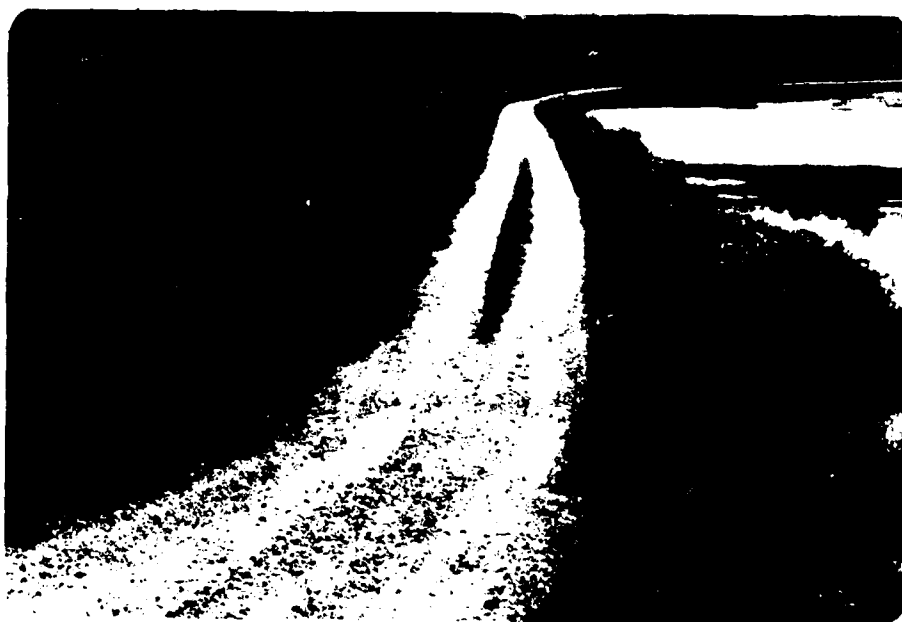
The gravel covered crest section of the earth spillway (see Photo 4) appeared to be in good condition, without signs of erosion. A line of metal fence posts without fence fabric (see Photo 3) crosses the spillway approach channel from the lake. The upper reach of the spillway discharge channel, a grass covered trapezoidal section excavated in the hillside (see Photo 5) was found to be in good condition. The lower reach of the outlet channel is steep and has been eroded (see Photo 6) to the underlying bedrock. Old tires and discarded machinery have been placed in this portion of the channel presumably in an attempt to control further erosion. The outlet channel flows into a natural draw which in turn joins Lower Lake Minnie Ha-Ha about 400 feet below the upper lake dam.

NO. 4: SPILLWAY (PI P)
